**Flood Control Project Maintenance
Levee Inspections**
LMA District Cover Sheet
Spring 2019 Levee Inspection Results

Reclamation District No. 1001 Nicolaus

Spring 2019 Levee Inspection Results

Waterway	Bank	Unit Miles
Unit No. 01 Yankee Slough	Right	4.12

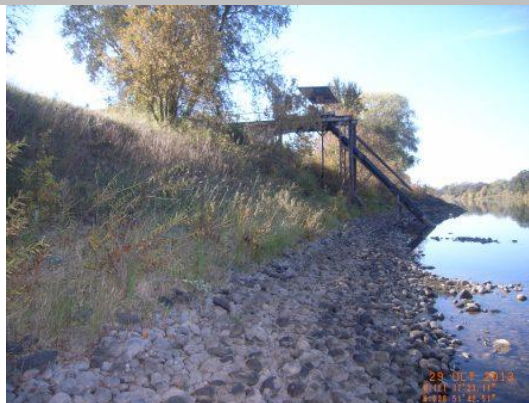
Photo 1 of 1 : SP_2019_RD1001_38_15_20190305_00005.jpg

LM Start	6.57	Rating **	A/W	Issue No.	15
LM End	6.77	Issue Type +	Ma	Location *	WS
Category	Supplemental			GPS Latitude/Longitude	
				Start	End
Item	2017 USACE Erosion Survey, DRAFT			38.863946 °	38.861558 °
				-121.621388 °	-121.623316 °
DWR ID	DWR_RD1001_04_f_2018_15				
Comment Code					
Inspector Comment					
2017 Site ID: FHR 5.8 L					
Status: Eroding					
2017 Field Notes: slope is not stable enough to maintain vegetation growth, new erosion					
Site History: 2011 - Large slumped sections on the lower bank. 2012 - New cracks observed.

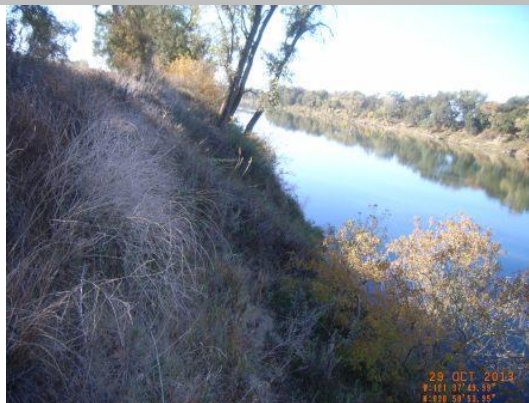
Photo 1 of 1 : SP_2019_RD1001_38_14_20190305_00004.jpg

Comment Code					
Inspector Comment					
2017 Site ID: FHR 5.0 L Status: Critical 2017 Field Notes: Upgraded to critical, significant new erosion, entire bank slope is vertical with non cohesive soils. Site History: 2000 - Steep bank off berm with some slumps and fallen trees, continued erosion. 2002 - Site lengthened upstream and downstream due to vertical bank along most of the reach. 2010 - Site extended upstream. 2011 - Minimal new erosion. 2012 - Site extended on the upstream end, new tree pop-out, and bank erosion continues to worsen. 2013 - Minor new erosion at the toe and top of bank. Inspector notes: The erosion is not into the levee prism, Spring 2019.

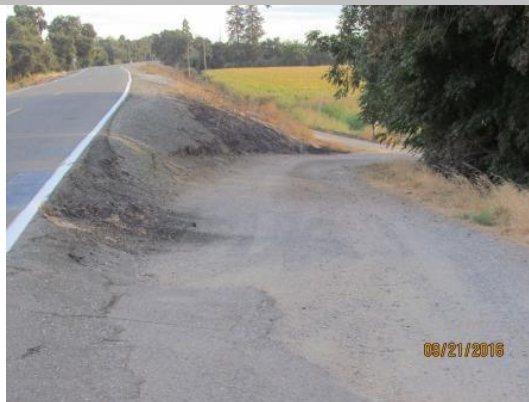
Photo 1 of 1 : SP_2019_RD1001_38_36_20190305_00021.jpg

LM Start	7.60	Rating **	A/W	Issue No.	36
LM End	7.60	Issue Type +	Ob	Location *	LS
Category	Earthen Levee			GPS Latitude/Longitude	
				Start	End
Item	Erosion / Bank Caving			38.850521 °	38.850521 °
				-121.629423 °	-121.629423 °
DWR ID	DWR_RD1001_04_f_2015_36				
Comment Code					
E2 : Schedule repair of erosion site prior to the next inspection.					
Inspector Comment					
Ramp has vertical cut into the levee prism.

View of vertical cut for ramp in the landside levee slope looking upstream.

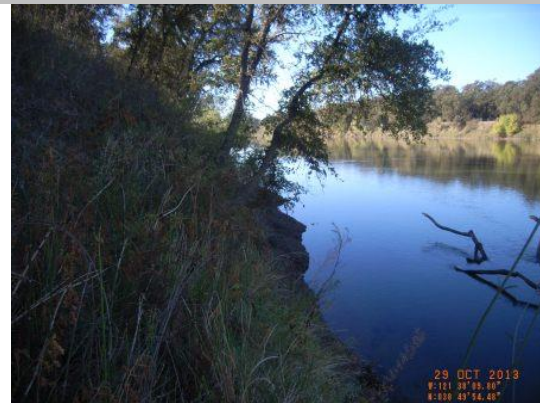
Photo 1 of 1 : SP_2019_RD1001_38_13_20190305_00003.jpg

LM Start	8.57	Rating **	A/W	Issue No.	13
LM End	8.97	Issue Type +	Ma	Location *	WS
Category	Supplemental			GPS Latitude/Longitude	
				Start	End
Item	2017 USACE Erosion Survey, DRAFT			38.836966 °	38.831498 °
				-121.634128 °	-121.636371 °
DWR ID	DWR_RD1001_04_f _ 2018_13				
Comment Code					
Inspector Comment					
2017 Site ID: FHR 3.8 L					
Status: Eroding					
2017 Field Notes: New erosion along lower slope					
Site History: 2006 - Sandy, silty bank with intermittent pockets of erosion. Rotational failure and tree pop outs are most of the problem. Some upper slope fluvial erosion. 2010 - Site extended upstream. The lower Feather may benefit from a regional repair. 2011 - Site combined with 3.6. Minimal new erosion. 2013 - New erosion observed at bank toe. Trees on site now have exposed roots.

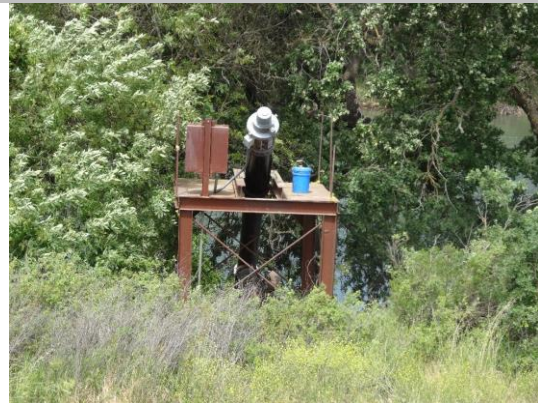
Photo 1 of 3 : UCIP_SP_2019_14563_24002.jpg

Comment Code						
Inspector Comment						
FS_ID:14563 DS_ID:22577 EP_NO: 12828 Repair Type: Non-Urgent Crossing Status: Found UCIP Comments: 05/16/2013 - needs detailed investigation for road surface cracks (P. Amatya - DWR UCIP) FIELD_STRUCT_DESC: 16-inch asphalt coated steel irrigation discharge pipe through the levee, 4.3 feet below the crown. 30-horsepower slant pump and platform on the riverbank. (16-inch irrigation discharge pipe and 30-horsepower slant pump authorized under Permit No. 12828, 1979. It is assumed that this 16-inch pipe replaces the abandoned 10-inch steel pipe referenced in the O&M Manual). [Additional Reference(s): DWR Levee Log, 1993. USACE Sacramento O&M Manual 141.1, August 1955, (RM 3.3), abandoned 10-inch steel pipe referenced]. FS Date: 5/16/2013

WS- slanted pipe in steel structure on river bank.

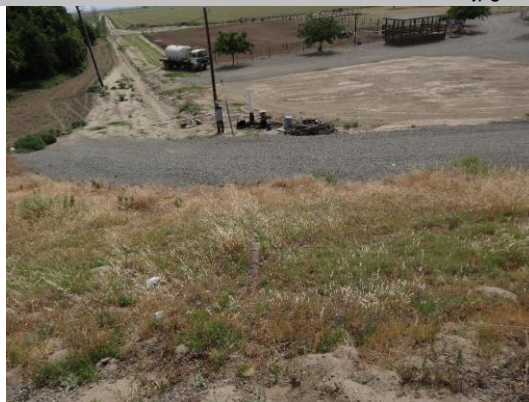
Photo 3 of 3 : UCIP_SP_2019_14544_23964.jpg

LM Start	9.44	Rating **	M	Issue No.	155 (cont)	
LM End	9.44	Issue Type +	En	Location *		
Category	Supplemental			GPS Latitude/Longitude		
				Start		End
Item	DWR UCIP Field Study			38.825107 °		38.825107 °
				-121.639369 °		-121.639369 °
DWR ID	22592					
Comment Code						
Inspector Comment						
FS_ID:14544 DS_ID:22592 EP_NO: N/A Repair Type: Non-Urgent Crossing Status: Found UCIP Comments: 05/16/2013 - seems abandoned pipe crossing.- needs properly abandoned.- a 48" steel tank not found on landside. (P. Amatya - DWR UCIP) FIELD_STRUCT_DESC: 12-inch steel irrigation discharge pipe through the levee, 5 feet below the crown. Pump on the riverbank. Pipe discharges into a 48-inch steel tank at the landside (LS) toe. (Johnston). [Additional Reference(s): DWR Levee Log, 1993. USACE Sacramento O&M Manual 141.1, August 1955, (RM 3.1)]. FS Date: 5/16/2013

LS- overview of landside, steel pipe on levee slope.

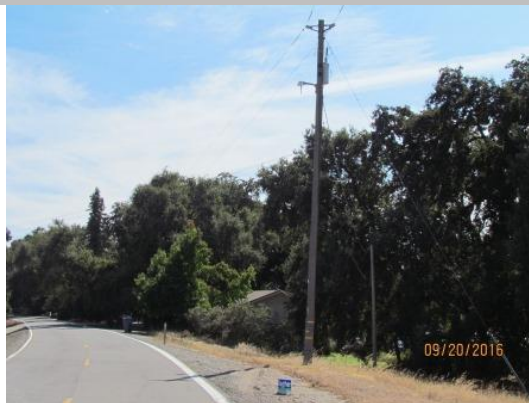
Photo 1 of 1 : SP_2019_RD1001_38_80_20190305_00043.jpg

LM Start	9.52	Rating **	M	Issue No.	80
LM End	9.52	Issue Type +	En	Location *	WS
Category	Earthen Levee			GPS Latitude/Longitude	
				Start	End
Item	Encroachments			38.823911 °	38.823911 °
				-121.639869 °	-121.639869 °
DWR ID	DWR_RD1001_04_s_2016_80				
Comment Code					
PO : Pole					
Inspector Comment

View of pole on waterside crown.

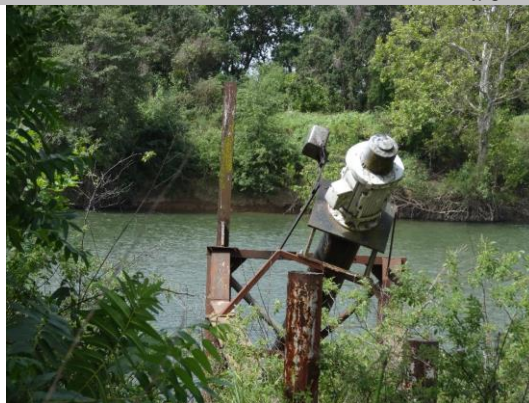
Photo 3 of 3 : UCIP_SP_2019_14627_24132.jpg

Comment Code						
Inspector Comment						
FS_ID:14627 DS_ID:22578 EP_NO: 3297 Repair Type: Non-Urgent Crossing Status: Found UCIP Comments: 05/16/2013 - needs properly abandoned.- dismantled standpipe found on LS levee slope (P. Amatya - DWR UCIP) FIELD_STRUCT_DESC: 12-inch steel irrigation discharge pipe through the levee, 3 feet below the crown. Slant pump mounted on a steel structure on the riverbank. Siphon breaker on the landside (LS) shoulder. Pipe discharges into a 24-inch concrete standpipe at the LS toe. (12-inch pipe and pump authorized under Permit No. 3297, 1960 - Albert Linggi). [Additional Reference(s): DWR Levee Log, 1993]. FS Date: 5/16/2013

WS- abandoned slanted pump station in steel pipe structure in river bank.

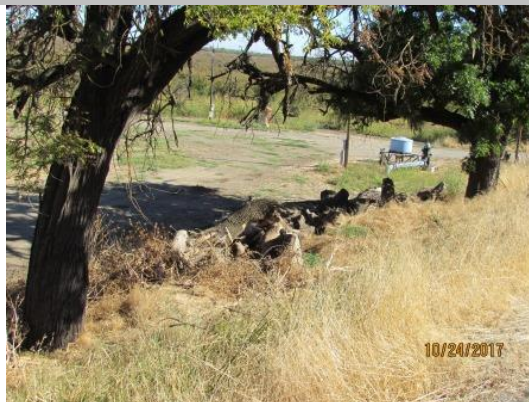
Photo 1 of 1 : SP_2019_RD1001_38_66_20190305_00036.jpg

LM Start	9.97	Rating **	M	Issue No.	66
LM End	9.97	Issue Type +	En	Location *	LS
Category	Earthen Levee			GPS Latitude/Longitude	
				Start	End
Item	Encroachments			38.817659 °	38.817659 °
				-121.638404 °	-121.638404 °
DWR ID	DWR_RD1001_04_f_2016_66				
Comment Code					
TR : Tree or limb					
Inspector Comment					
Downed tree pushed up to levee toe needs to be removed, Fall 2018.

View of large tree pushed up to the landside levee toe.

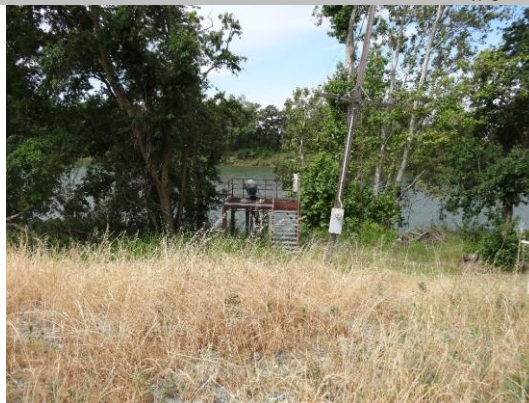
Photo 1 of 3 : UCIP_SP_2019_41723_23977.jpg

Comment Code					
Inspector Comment					
FS_ID:41723 DS_ID:22572 EP_NO: 1881 Repair Type: Non-Urgent Crossing Status: Found UCIP Comments: 05/16/2013 - burried slide gate found on WS slope.- concrete box at the landward toe not found. (P. Amatya - DWR UCIP) FIELD_STRUCT_DESC: 18-inch steel irrigation discharge pipe through the levee, 5 feet below the crown. Slant pump mounted on a pile structure on the riverbank. Gate valve on the waterside (WS) slope. Siphon breaker on the landside (LS) shoulder. Pipe discharges into a concrete box at the LS toe. (18-inch steel discharge pipe and slant pump authorized under Permit No. 1881, 1954 - L. G. Kipp and R. B. Reith). [Additional Reference(s): DWR Levee Log, 1993]. FS Date: 5/16/2013

WS- slant pump on steel structure in river bank.

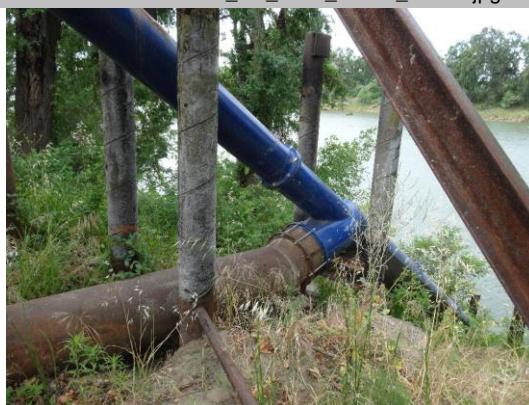
Photo 2 of 3 : UCIP_SP_2019_41723_23976.jpg

WS- main steel pipe on levee surface (without paint).

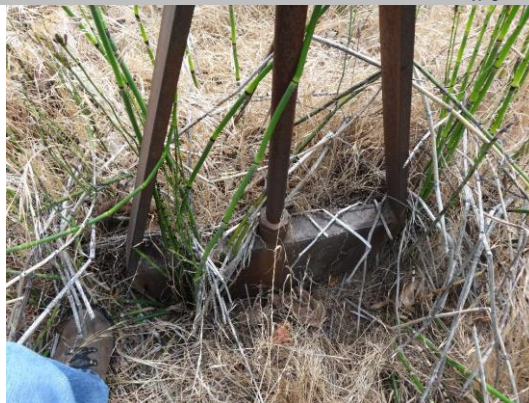
Photo 3 of 3 : UCIP_SP_2019_41723_23978.jpg

Item	DWR UCIP Field Study			38.815530 °	38.815530 °	
				-121.636918 °	-121.636918 °	
DWR ID	22572					
Comment Code						
Inspector Comment						
FS_ID:41723 DS_ID:22572 EP_NO: 1881 Repair Type: Non-Urgent Crossing Status: Found UCIP Comments: 05/16/2013 - burried slide gate found on WS slope.- concrete box at the landward toe not found. (P. Amatya - DWR UCIP) FIELD_STRUCT_DESC: 18-inch steel irrigation discharge pipe through the levee, 5 feet below the crown. Slant pump mounted on a pile structure on the riverbank. Gate valve on the waterside (WS) slope. Siphon breaker on the landside (LS) shoulder. Pipe discharges into a concrete box at the LS toe. (18-inch steel discharge pipe and slant pump authorized under Permit No. 1881, 1954 - L. G. Kipp and R. B. Reith). [Additional Reference(s): DWR Levee Log, 1993]. FS Date: 5/16/2013

WS- gate valve on levee slope.

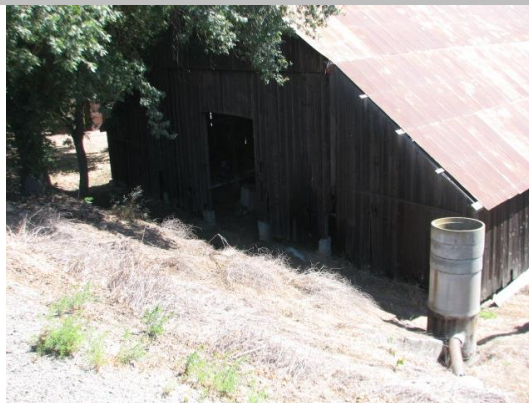
Photo 1 of 1 : SP_2019_RD1001_38_29_20190305_00014.jpg

LM Start	10.60	Rating **	M	Issue No.	29
LM End	10.60	Issue Type +	En	Location *	LS
Category	Earthen Levee			GPS Latitude/Longitude	
				Start	End
Item	Encroachments			38.809256 °	38.809256 °
				-121.633908 °	-121.633908 °
DWR ID	DWR_RD1001_04_s_2013_29				
Comment Code					
BU : Building					
Inspector Comment

The building is within the easement of the levee.

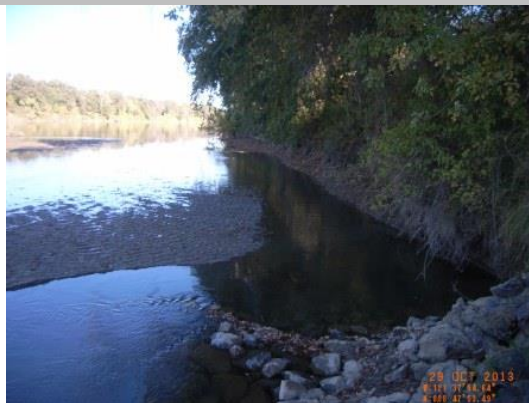
Photo 1 of 1 : SP_2019_RD1001_38_10_20190305_00002.jpg

LM Start	11.18	Rating **	M	Issue No.	10
LM End	11.37	Issue Type +	Ma	Location *	WS
Category	Supplemental			GPS Latitude/Longitude	
				Start	End
Item	2017 USACE Erosion Survey, DRAFT			38.800920 °	38.798165 °
				-121.633050 °	-121.631939 °
DWR ID	DWR_RD1001_04_f_2018_10				
Comment Code					
Inspector Comment					
2017 Site ID: FHR 1.0 L					
Status: Eroding					
2017 Field Notes: Significant new erosion along lower bank.					
Site History: 2000 - Site is relatively stable except for some toe erosion at the upstream end, recommend monitoring the upstream end. 2004 - Some new block failures (10ft deep) at the toe of the upstream end. 2007 - Some minor new slumping at the waterline. 2013 - Minor new erosion along the bank toe.

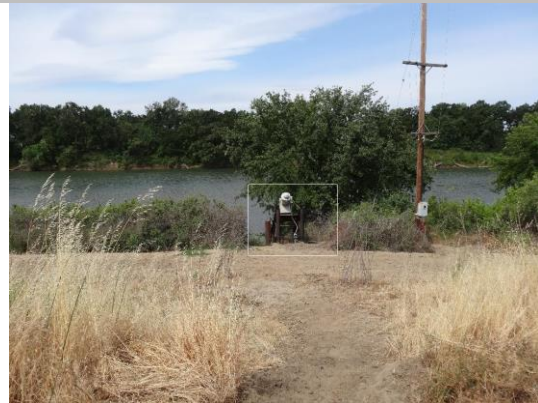
Photo 1 of 3 : UCIP_SP_2019_14548_23970.jpg

Comment Code						
Inspector Comment						
FS_ID:14548 DS_ID:22580 EP_NO: 3489 Repair Type: Non-Urgent Crossing Status: Found UCIP Comments: 05/16/2013 - siphon breaker on the landward shoulder not found.- cracked road surface along the pipe alienment. Needs more investigations. (P. Amatya - DWR UCIP) FIELD_STRUCT_DESC: 16-inch irrigation discharge pipe of an unknown material through the levee, 3 feet below the crown. 40-horsepower slant pump mounted on a steel structure on the riverbank. Pipe discharges into a 36-inch concrete standpipe at the landside (LS) toe. (16-inch pipe and 40-horsepower pump authorized under Permit No. 3489, 1960 - Kirtland Brothers; name change authorized under Permit No. 3489-1, 2018 - Global AG Properties USA LLC c/o WGIM, Inc.) [Additional Reference(s): DWR Levee Log, 1993]. FS Date: 5/16/2013

WS- slant pump on river bank.

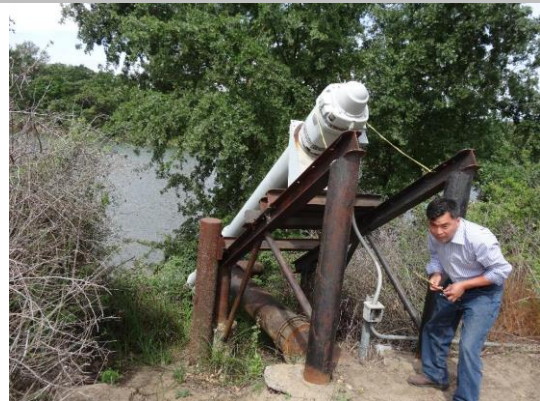
Photo 3 of 3 : UCIP_SP_2019_14548_23968.jpg

WS- slant pump, pipe on steel piles.

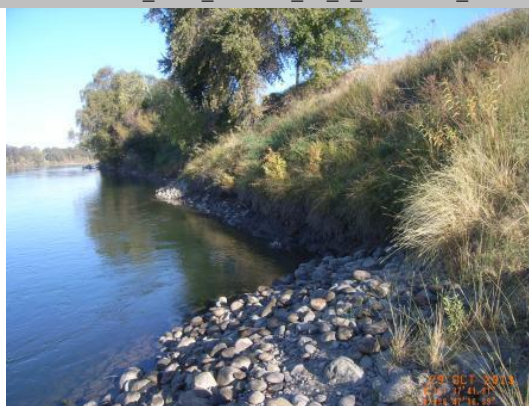
Photo 1 of 1 : SP_2019_RD1001_38_9_20190305_00001.jpg

LM Start	11.59	Rating **	M	Issue No.	9	
LM End	11.75	Issue Type +	Ma	Location *	WS	
Category	Supplemental			GPS Latitude/Longitude		
				Start	End	
Item	2017 USACE Erosion Survey, DRAFT			38.795455 °	38.793394 °	
				-121.629903 °	-121.628156 °	
DWR ID	DWR_RD1001_04_f_2018_9					
Comment Code						
Inspector Comment						
2017 Site ID: FHR 0.6 L						
Status: Eroding						
2017 Field Notes: Further toe erosion, with sections of sand deposition.						
Site History: 1997- Deposits over top of cobble on the upper slope.						
2000 - Old cobble site in poor shape; some toe retreat, but little change; steep bank. 2010 - Site extended upstream due to new toe erosion.						
2012 - Minor new erosion at toe, new slumping, animals holes and cracks observed.

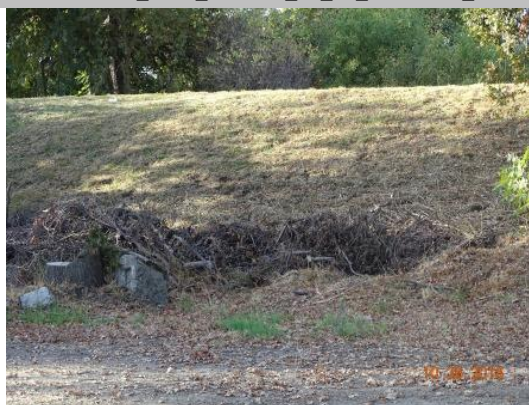
Photo 1 of 1 : SP_2019_RD1001_38_53_20190305_00028.jpg

LM Start	12.44	Rating **	M	Issue No.	53
LM End	12.44	Issue Type +	En	Location *	LS
Category	Earthen Levee			GPS Latitude/Longitude	
				Start	End
Item	Encroachments			38.786444 °	38.786444 °
				-121.619165 °	-121.619165 °
DWR ID	DWR_RD1001_04_s_2018_53				
Comment Code					
PR : Prunings					
Inspector Comment					
Remove prunings from levee toe, Spring 2019.

View looking at landside toe of prunings on levee toe, Fall 2018.

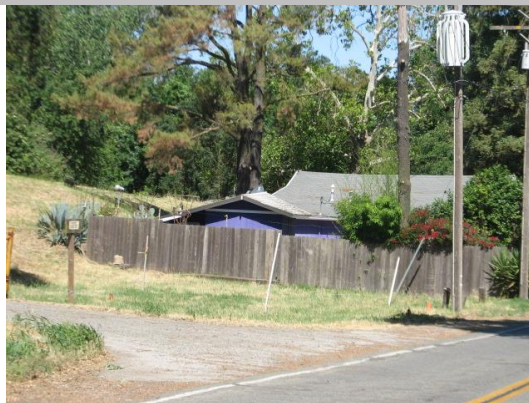
Photo 1 of 1 : SP_2019_RD1001_38_25_20190305_00011.jpg

LM Start	12.48	Rating **	U	Issue No.	25
LM End	12.48	Issue Type +	En	Location *	LS
Category	Earthen Levee			GPS Latitude/Longitude	
				Start	End
Item	Encroachments			38.786073 °	38.786073 °
				-121.618522 °	-121.618522 °
DWR ID	DWR_RD1001_04_s_2012_25				
Comment Code					
BU : Building					
Inspector Comment

An unpermitted building is at the toe of the levee.

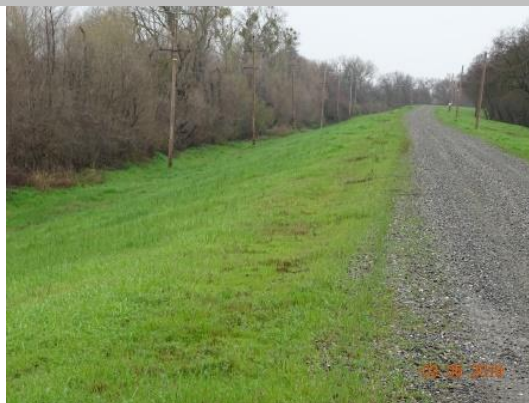
Photo 1 of 1 : SP_2019_RD1001_39_12_20190320_00020.jpg

LM Start	0.00	Rating **	A	Issue No.	12
LM End	5.38	Issue Type +	Ma	Location *	LS
Category	Earthen Levee			GPS Latitude/Longitude	
				Start	End
Item	Vegetation			38.781189 °	38.830994 °
				-121.605442 °	-121.529875 °
DWR ID	DWR_RD1001_05_s_2019_12				
Comment Code					
V1 : Control annual grass and weeds on the levee slopes and easements.					
Inspector Comment					
The annual vegetation is well maintained, Spring 2019.

View looking upstream landside at the well maintained annual vegetation, Spring 2019.

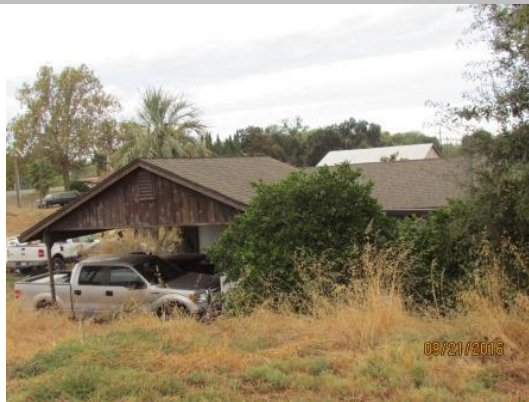
Photo 1 of 1 : SP_2019_RD1001_39_13_20190305_00006.jpg

LM Start	0.05	Rating **	M	Issue No.	13
LM End	0.05	Issue Type +	En	Location *	LS
Category	Earthen Levee			GPS Latitude/Longitude	
				Start	End
Item	Encroachments			38.781881 °	38.781881 °
				-121.605215 °	-121.605215 °
DWR ID	DWR_RD1001_05_f_2016_13				
Comment Code					
BU : Building					
Inspector Comment					
House and carport are at landside levee toe.

View of a house and carport that are at the levee toe.

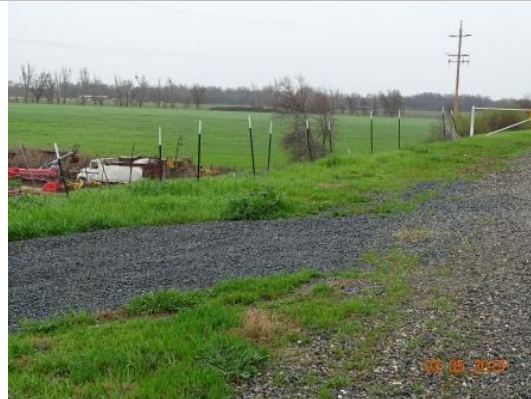
Photo 1 of 1 : SP_2019_RD1001_39_15_20190320_00019.jpg

LM Start	0.09	Rating **	M	Issue No.	15
LM End	0.11	Issue Type +	En	Location *	LS
Category	Earthen Levee			GPS Latitude/Longitude	
				Start	End
Item	Encroachments			38.782447 °	38.782717 °
				-121.605008 °	-121.604870 °
DWR ID	DWR_RD1001_05_s_2019_15				
Comment Code					
FE : Fence					
Inspector Comment					
Temporary fence needs to be removed, Spring 2019.

View looking upstream landside at a temporary goat fence, Spring 2019.

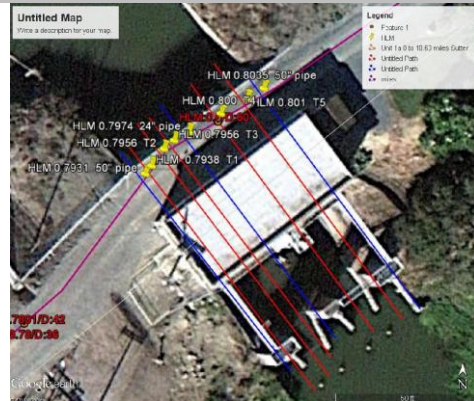
Photo 1 of 3 : UCIP_SP_2019_14393_23697.jpg

FS_ID:14393
DS_ID:22610
EP_NO: N/A
Repair Type: Non-Urgent
Crossing Status: Found
UCIP Comments: 05/15/2013 - needs repair of concrete piers on waterside. Rebar exposed from the pier. Even though this pier is functionally not linked to the pipe, it needs repair. (P. Amatya - DWR UCIP)
FIELD_STRUCT_DESC: 5 of 8: 24-inch reinforced concrete drainage discharge pipe through the levee, 25 feet below the crown. Five 60-inch by 84-inch reinforced concrete drainage tunnels through the levee, 25 feet below the crown. One tunnel has a 60-inch pump installed inside and is gated on the waterside (WS) end. Two 50-inch steel drainage discharge pipes through the levee, 25 feet below the crown. All tunnels and pipes are gated. Concrete headwall and railing along the landside (LS). (Reclamation District No. 1001). [Additional Reference(s): DWR Levee Log, 1993].
FS Date: 5/15/2013

Location of pipes and tunnels. 24-inch steel pipe located at 5th from the left.

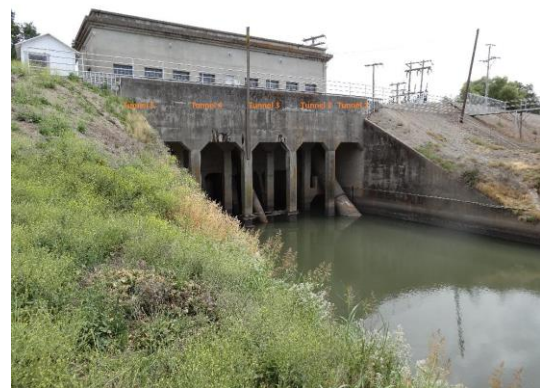
Photo 2 of 3 : UCIP_SP_2019_14393_23696.jpg

LS- Drainage structure with tunnels, pipes and pump house. Tunnel 1 at far right and tunnel 5 at far left. The pipe is located inside tunnel 3.

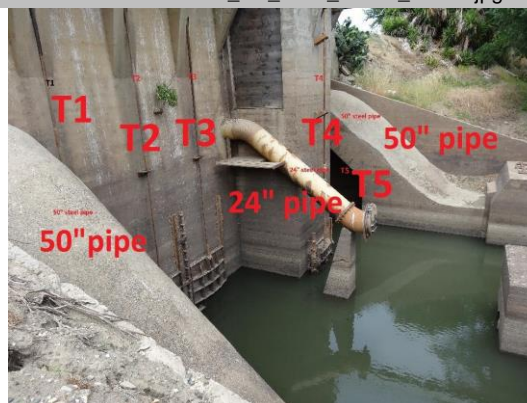
Photo 3 of 3 : UCIP_SP_2019_14393_23799.jpg

Comment Code						
Inspector Comment						
FS_ID:14393 DS_ID:22610 EP_NO: N/A Repair Type: Non-Urgent Crossing Status: Found UCIP Comments: 05/15/2013 - needs repair of concrete piers on waterside. Rebar exposed from the pier. Even though this pier is functionally not linked to the pipe, it needs repair. (P. Amatya - DWR UCIP) FIELD_STRUCT_DESC: 5 of 8: 24-inch reinforced concrete drainage discharge pipe through the levee, 25 feet below the crown. Five 60-inch by 84-inch reinforced concrete drainage tunnels through the levee, 25 feet below the crown. One tunnel has a 60-inch pump installed inside and is gated on the waterside (WS) end. Two 50-inch steel drainage discharge pipes through the levee, 25 feet below the crown. All tunnels and pipes are gated. Concrete headwall and railing along the landside (LS). (Reclamation District No. 1001). [Additional Reference(s): DWR Levee Log, 1993]. FS Date: 5/15/2013

WS- three steel pipes inside tunnel. Fifty inch pipes on left and right. Twenty four inch pipe in middle of the structure as shown.

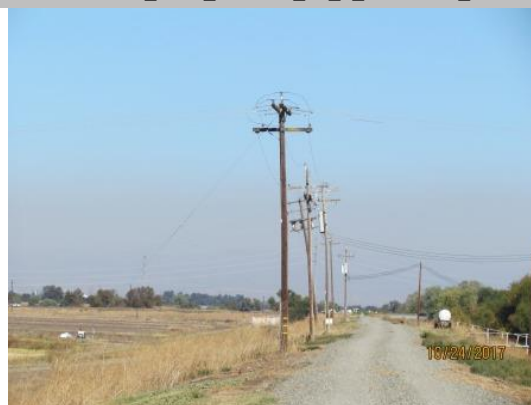
Photo 1 of 1 : SP_2019_RD1001_39_7_20190305_00001.jpg

LM Start	3.56	Rating **	M	Issue No.	7
LM End	3.81	Issue Type +	En	Location *	LS
Category	Earthen Levee			GPS Latitude/Longitude	
				Start	End
Item	Encroachments			38.814919 °	38.817178 °
				-121.556712 °	-121.552965 °
DWR ID	DWR_RD1001_05_s_2012_7				
Comment Code					
PO : Pole					
Inspector Comment

View of poles on the landside shoulder looking downstream.

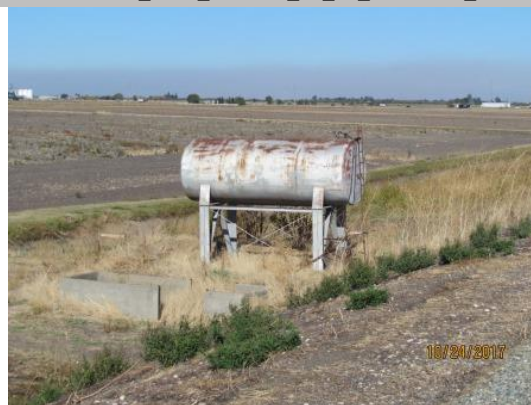
Photo 1 of 1 : SP_2019_RD1001_39_10_20190305_00005.jpg

LM Start	3.81	Rating **	M	Issue No.	10
LM End	3.81	Issue Type +	En	Location *	LS
Category	Earthen Levee			GPS Latitude/Longitude	
				Start	End
Item	Encroachments			38.817178 °	38.817178 °
				-121.552965 °	-121.552965 °
DWR ID	DWR_RD1001_05_s_2012_10				
Comment Code					
TA : Tank					
Inspector Comment					
Fuel tank at landside levee toe.

View of tank on the landside shoulder looking downstream.

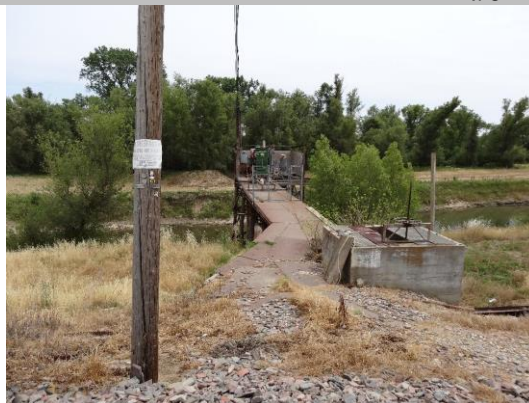
Photo 1 of 3 : UCIP_SP_2019_14486_23913.jpg

Comment Code					
Inspector Comment					
FS_ID:14486 DS_ID:22604 EP_NO: 1896 Repair Type: Non-Urgent Crossing Status: Found UCIP Comments: 05/15/2013 - slide gate in concrete box on waterside levee toe.- cracked headwall on landside- working during field survey- abandoned steel pipe, may need to remove it or properly adandoned. (P. Amatya - DWR UCIP) FIELD_STRUCT_DESC: *ABANDONED* 1 of 3: 20-inch asbestos bonded corrugated metal irrigation discharge pipe through the levee, 2.13 feet below the crown. Three vertical pumps on a wooden piling structure in the stream. Walkway to the pumps. Slide gate in a concrete box on the waterside (WS). (Permit No. 1896, [permit missing]). [Additional Reference(s): DWR Levee Log, 1993]. FS Date: 5/15/2013

WS- pump station, walkway, and slide gate in concrete box.

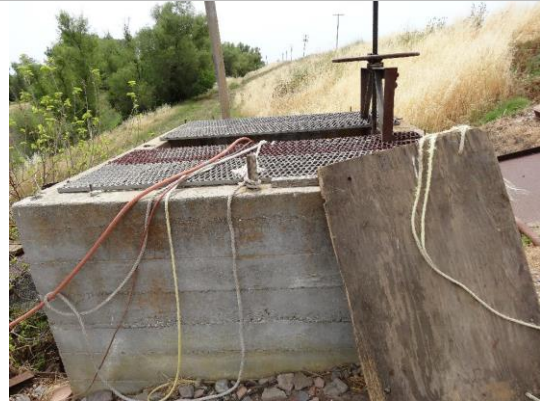
Photo 3 of 3 : UCIP_SP_2019_14486_23911.jpg

Comment Code					
Inspector Comment					
FS_ID:14486 DS_ID:22604 EP_NO: 1896 Repair Type: Non-Urgent Crossing Status: Found UCIP Comments: 05/15/2013 - slide gate in concrete box on waterside levee toe.- cracked headwall on landside- working during field survey- abandoned steel pipe, may need to remove it or properly adandoned. (P. Amatya - DWR UCIP) FIELD_STRUCT_DESC: *ABANDONED* 1 of 3: 20-inch asbestos bonded corrugated metal irrigation discharge pipe through the levee, 2.13 feet below the crown. Three vertical pumps on a wooden piling structure in the stream. Walkway to the pumps. Slide gate in a concrete box on the waterside (WS). (Permit No. 1896, [permit missing]). [Additional Reference(s): DWR Levee Log, 1993]. FS Date: 5/15/2013

WS- slide gate in concrete box on levee toe.

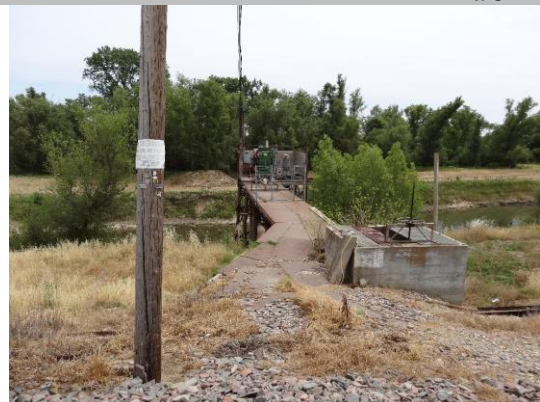
Photo 1 of 3 : UCIP_SP_2019_14484_23894.jpg

Comment Code					
Inspector Comment					
FS_ID:14484 DS_ID:22595 EP_NO: 1896 Repair Type: Non-Urgent Crossing Status: Found UCIP Comments: 05/15/2013 - slide gate in concrete box on waterside levee toe.- cracked headwall on landside- working during field survey (P. Amatya - DWR UCIP) FIELD_STRUCT_DESC: *ABANDONED* 2 of 3: 20-inch asbestos bonded corrugated metal irrigation discharge pipe through the levee, 2.13 feet below the crown. Three vertical pumps on a wooden piling structure in the stream. Walkway to the pumps. Slide gate in a concrete box on the waterside (WS). (Permit No. 1896, [permit missing]). [Additional Reference(s): DWR Levee Log, 1993]. FS Date: 5/15/2013

WS- overview of pump station, walkway, and slide gate in concrete box.

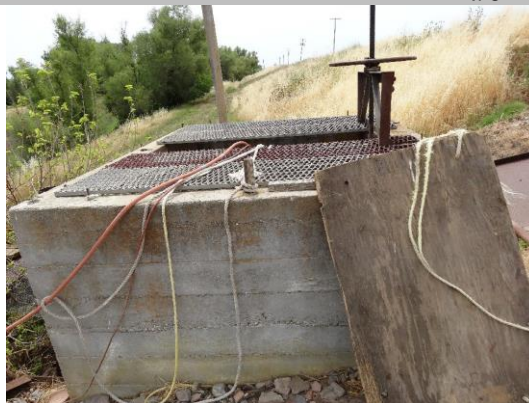
Photo 2 of 3 : UCIP_SP_2019_14484_23898.jpg

Comment Code						
Inspector Comment						
FS_ID:14484 DS_ID:22595 EP_NO: 1896 Repair Type: Non-Urgent Crossing Status: Found UCIP Comments: 05/15/2013 - slide gate in concrete box on waterside levee toe.- cracked headwall on landside- working during field survey (P. Amatya - DWR UCIP) FIELD_STRUCT_DESC: *ABANDONED* 2 of 3: 20-inch asbestos bonded corrugated metal irrigation discharge pipe through the levee, 2.13 feet below the crown. Three vertical pumps on a wooden piling structure in the stream. Walkway to the pumps. Slide gate in a concrete box on the waterside (WS). (Permit No. 1896, [permit missing]). [Additional Reference(s): DWR Levee Log, 1993]. FS Date: 5/15/2013

WS- slide gate in concrete box on levee toe.

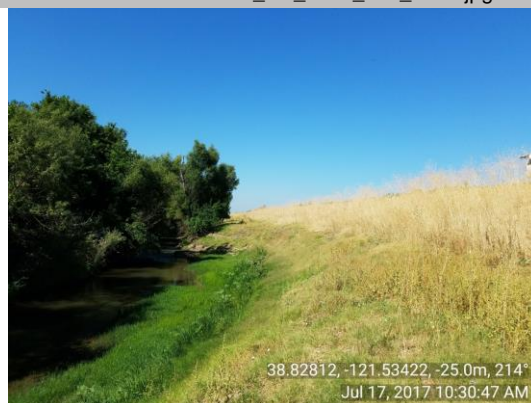
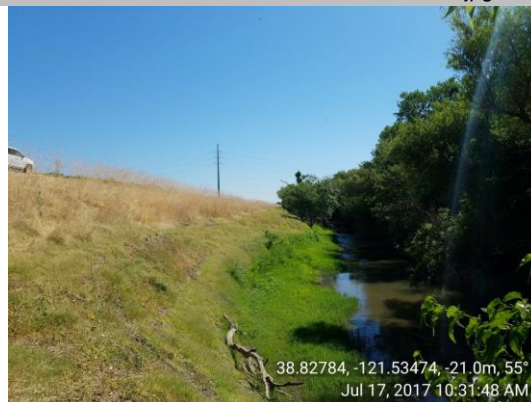
LM Start	5.05	Rating **	A/W	Issue No.	8 (cont)	
LM End	5.06	Issue Type +	Ma	Location *		
Category	Supplemental			GPS Latitude/Longitude		
				Start	End	
Item	2017 Storm Damage			38.828100°	38.828188°	
				-121.534740°	-121.534625°	
DWR ID	DWR_RD1001_05_f_2017_8					
Comment Code						
Inspector Comment						
Levee Evaluation Comments						
Description:						
Site ID No:493						
Site Designation:RD 1001-03						
Repair Type: Erosion						
Rating:Serious						
Field Date:7/17/2017						
Notes: Serious per senior review

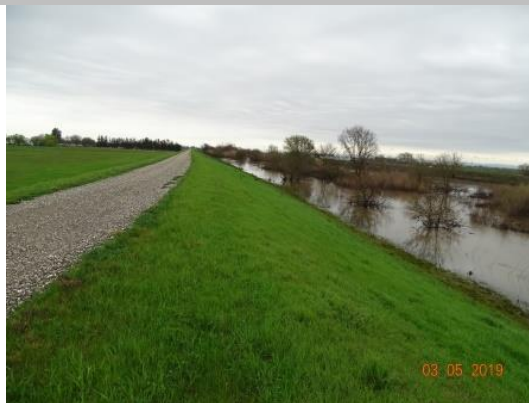
Photo 1 of 1 : SP_2019_RD1001_40_14_20190320_00038.jpg

LM Start	0.01	Rating **	A	Issue No.	14
LM End	4.74	Issue Type +	Ma	Location *	WS
Category	Earthen Levee			GPS Latitude/Longitude	
				Start	End
Item	Vegetation			38.831162 °	38.896395 °
				-121.529601 °	-121.520190 °
DWR ID	DWR_RD1001_06_s_2019_14				
Comment Code					
V1 : Control annual grass and weeds on the levee slopes and easements.					
Inspector Comment					
The annual vegetation is well maintained, Spring 2019.

View looking upstream waterside at the well maintained annual vegetation, Spring 2019.

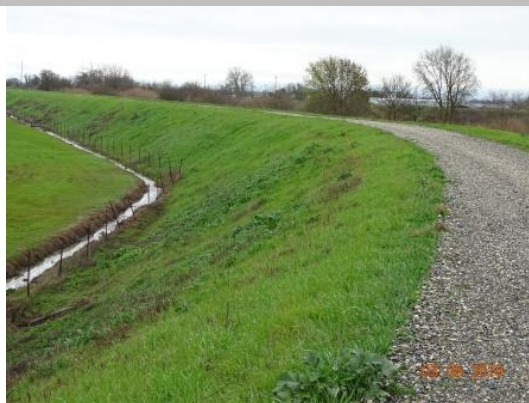
Photo 1 of 1 : SP_2019_RD1001_40_13_20190320_00037.jpg

LM Start	0.02	Rating **	A	Issue No.	13
LM End	4.74	Issue Type +	Ma	Location *	LS
Category	Earthen Levee			GPS Latitude/Longitude	
				Start	End
Item	Vegetation			38.831223 °	38.896395 °
				-121.529534 °	-121.520190 °
DWR ID	DWR_RD1001_06_s_2019_13				
Comment Code					
V1 : Control annual grass and weeds on the levee slopes and easements.					
Inspector Comment					
The annual vegetation is well maintained, Spring 2019.

View looking upstream landside at the well maintained annual vegetation, Spring 2019.

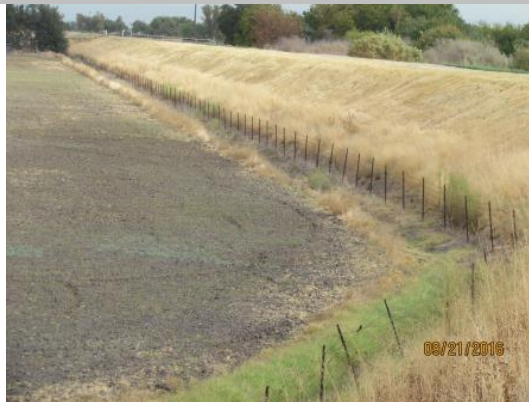
Photo 1 of 1 : SP_2019_RD1001_40_20_20190305_00007.jpg

LM Start	0.02	Rating **	M	Issue No.	20
LM End	0.43	Issue Type +	En	Location *	LS
Category	Earthen Levee			GPS Latitude/Longitude	
				Start	End
Item	Encroachments			38.831243 °	38.836832 °
				-121.529519 °	-121.526810 °
DWR ID	DWR_RD1001_06_f_2016_20				
Comment Code					
FE : Fence					
Inspector Comment					
There is a fence along the landside levee toe.

View of fence along the landside levee toe looking upstream.

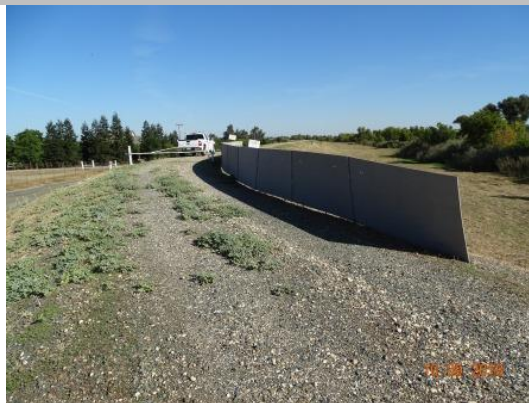
Photo 1 of 1 : SP_2019_RD1001_40_16_20190305_00004.jpg

LM Start	0.47	Rating **	U	Issue No.	16
LM End	0.47	Issue Type +	En	Location *	CR
Category	Earthen Levee			GPS Latitude/Longitude	
				Start	End
Item	Encroachments			38.837366 °	38.837366 °
				-121.526579 °	-121.526579 °
DWR ID	DWR_RD1001_06_f_2018_16				
Comment Code					
FE : Fence					
Inspector Comment					
The solid fence needs to be removed from the crown, Spring 2019.

View looking upstream waterside crown at an unpermitted solid fence, Fall 2018.

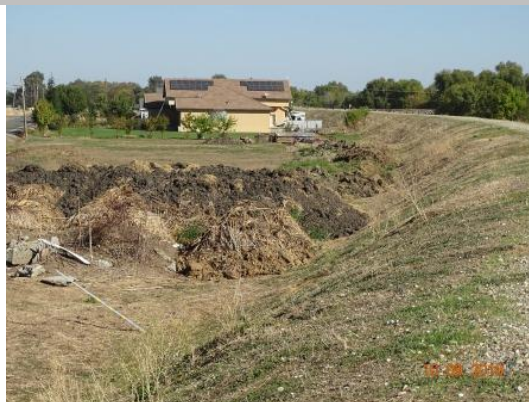
Photo 1 of 1 : SP_2019_RD1001_40_21_20190305_00008.jpg

LM Start	0.77	Rating **	U	Issue No.	21
LM End	0.85	Issue Type +	En	Location *	LS
Category	Earthen Levee			GPS Latitude/Longitude	
				Start	End
Item	Encroachments			38.841522 °	38.842611 °
				-121.524833 °	-121.524533 °
DWR ID	DWR_RD1001_06_f_2018_21				
Comment Code					
MA : Material					
Inspector Comment					
Soil material piled on the levee toe needs to be removed, Spring 2019.

View looking upstream landside where soil has been dumped on the levee toe, Fall 2018.

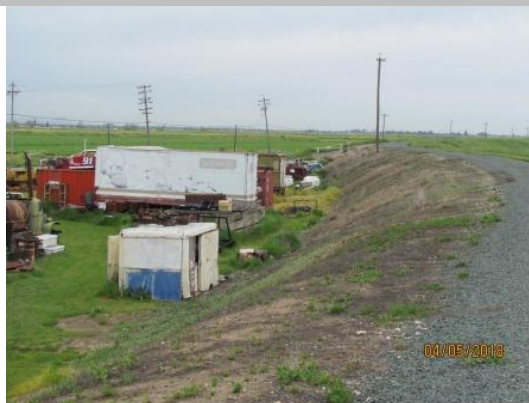
Photo 1 of 1 : SP_2019_RD1001_40_3_20190305_00001.jpg

LM Start	1.45	Rating **	M	Issue No.	3
LM End	1.53	Issue Type +	En	Location *	LS
Category	Earthen Levee			GPS Latitude/Longitude	
				Start	End
Item	Encroachments			38.851234 °	38.852445 °
				-121.524421 °	-121.524809 °
DWR ID	DWR_RD1001_06_s_2012_3				
Comment Code					
EQ : Equipment					
Inspector Comment					
Remove equipment from levee toe.

View looking upstream of the equipment at the landside levee toe.

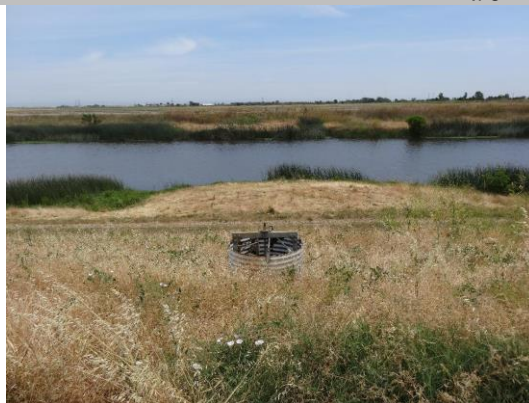
Photo 1 of 3 : UCIP_SP_2019_14244_23467.jpg

LM Start	1.72	Rating **	M	Issue No.	47
LM End	1.72	Issue Type +	En	Location *	
Category	Supplemental			GPS Latitude/Longitude	
				Start	End
Item	DWR UCIP Field Study			38.855186 °	38.855186 °
				-121.524895 °	-121.524895 °
DWR ID	22617				
Comment Code					
Inspector Comment					
FS_ID:14244 DS_ID:22617 EP_NO: N/A Repair Type: Non-Urgent Crossing Status: Found UCIP Comments: 05/15/2013 - visible damage to pipe on opening at inlet due to high corrosion.- video inspection recommended. (P. Amatya - DWR UCIP) FIELD_STRUCT_DESC: 36-inch corrugated metal gravity drainage pipe through the levee, 12.5 feet below the crown. Slide gate in a 48-inch corrugated metal pipe (CMP) riser on the waterside (WS) slope. Concrete headwall at the landside (LS) toe. Pipe crosses under the channel. [Additional Reference(s): DWR Levee Log, 1993]. FS Date: 5/15/2013

WS- slide gate in CMP riser on levee slope.

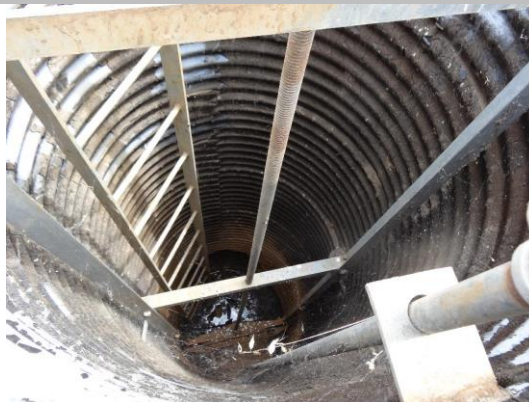
Photo 2 of 3 : UCIP_SP_2019_14244_23466.jpg

WS- slide gate, air vent pipe in CMP riser on levee slope.

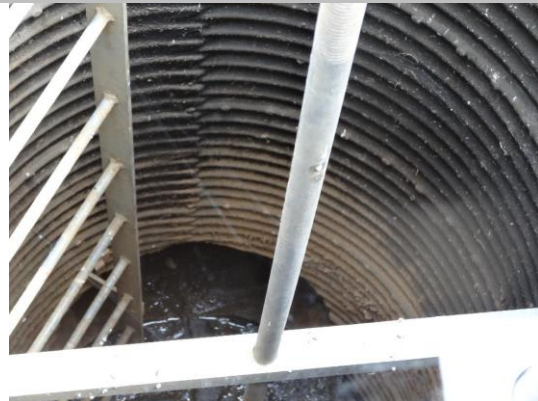
Photo 3 of 3 : UCIP_SP_2019_14244_23465.jpg

LM Start	1.72	Rating **	M	Issue No.	47 (cont)
LM End	1.72	Issue Type +	En	Location *	
Category	Supplemental			GPS Latitude/Longitude	
				Start	End
Item	DWR UCIP Field Study			38.855186 °	38.855186 °
				-121.524895 °	-121.524895 °
DWR ID	22617				
Comment Code					
Inspector Comment					
FS_ID:14244 DS_ID:22617 EP_NO: N/A Repair Type: Non-Urgent Crossing Status: Found UCIP Comments: 05/15/2013 - visible damage to pipe on opening at inlet due to high corrosion.- video inspection recommended. (P. Amatya - DWR UCIP) FIELD_STRUCT_DESC: 36-inch corrugated metal gravity drainage pipe through the levee, 12.5 feet below the crown. Slide gate in a 48-inch corrugated metal pipe (CMP) riser on the waterside (WS) slope. Concrete headwall at the landside (LS) toe. Pipe crosses under the channel. [Additional Reference(s): DWR Levee Log, 1993]. FS Date: 5/15/2013

WS- pipe opening visible inside CMP riser.

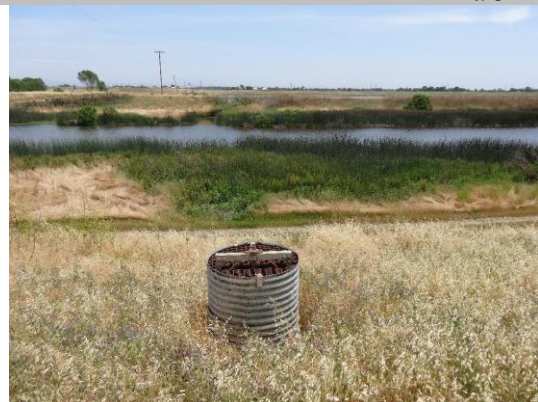
Photo 1 of 3 : UCIP_SP_2019_14223_23445.jpg

LM Start	2.03	Rating **	M	Issue No.	48
LM End	2.03	Issue Type +	En	Location *	
Category	Supplemental			GPS Latitude/Longitude	
				Start	End
Item	DWR UCIP Field Study			38.859601 °	38.859601 °
				-121.524885 °	-121.524885 °
DWR ID	22616				
Comment Code					
Inspector Comment					
FS_ID:14223 DS_ID:22616 EP_NO: N/A Repair Type: Non-Urgent Crossing Status: Found UCIP Comments: 05/15/2013 - pipe burried/submerged on LS- needs cleaning of LS pipe end opening. (P. Amatya - DWR UCIP) FIELD_STRUCT_DESC: 24-inch corrugated metal gravity drainage pipe through the levee, 15.5 feet below the crown. Slide gate in a 36-inch corrugated metal pipe (CMP) riser on the waterside (WS) slope. Concrete headwall at the landside (LS) toe. Pipe crosses under the channel. [Additional Reference(s): DWR Levee Log, 1993]. FS Date: 5/15/2013

WS- slide gate in CMP riser on levee slope.

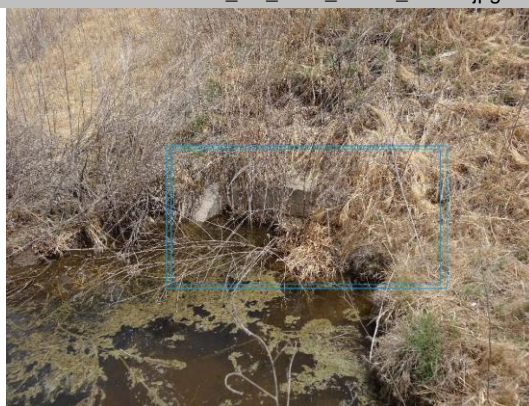
Photo 2 of 3 : UCIP_SP_2019_14223_23444.jpg

LM Start	2.03	Rating **	M	Issue No.	48 (cont)	
LM End	2.03	Issue Type +	En	Location *		
Category	Supplemental			GPS Latitude/Longitude		
				Start	End	
Item	DWR UCIP Field Study			38.859601 °	38.859601 °	
				-121.524885 °	-121.524885 °	
DWR ID	22616					
Comment Code						
Inspector Comment						
FS_ID:14223 DS_ID:22616 EP_NO: N/A Repair Type: Non-Urgent Crossing Status: Found UCIP Comments: 05/15/2013 - pipe burried/submerged on LS- needs cleaning of LS pipe end opening. (P. Amatya - DWR UCIP) FIELD_STRUCT_DESC: 24-inch corrugated metal gravity drainage pipe through the levee, 15.5 feet below the crown. Slide gate in a 36-inch corrugated metal pipe (CMP) riser on the waterside (WS) slope. Concrete headwall at the landside (LS) toe. Pipe crosses under the channel. [Additional Reference(s): DWR Levee Log, 1993]. FS Date: 5/15/2013

LS- concrete wing wall on levee toe

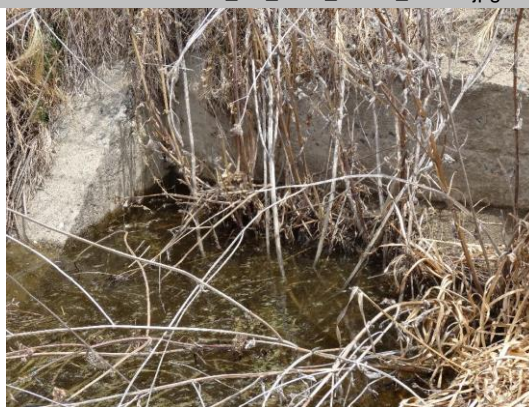
Photo 3 of 3 : UCIP_SP_2019_14223_23443.jpg

LS- pipe submerged/buried in concrete wing wall on levee toe

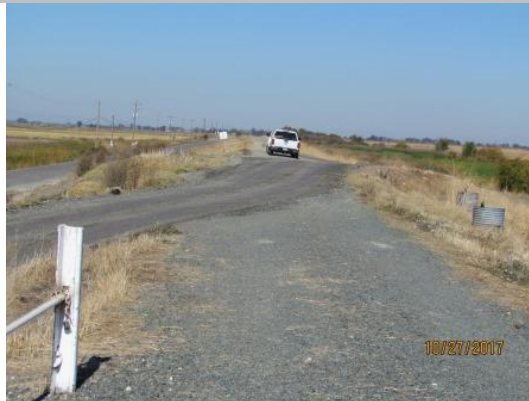
Photo 1 of 1 : SP_2019_RD1001_40_8_20190305_00003.jpg

LM Start	2.05	Rating **	A/W	Issue No.	8
LM End	2.05	Issue Type +	Ma	Location *	CR
Category	Earthen Levee			GPS Latitude/Longitude	
				Start	End
Item	Crown Surface / Depressions / Rutting			38.860002 °	38.860002 °
				-121.524873 °	-121.524873 °
DWR ID	DWR_RD1001_06_s_2012_8				
Comment Code					
C2 : Repair depressions or ruts in the crown or slope.					
Inspector Comment					
There are depressions on the crown where there is cross traffic. Monitor this area and fix as needed.

View of crown where there is cross traffic looking upstream. Monitor this area and fix as needed.

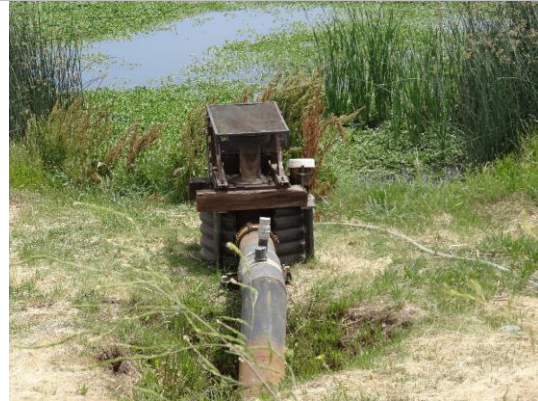
Photo 2 of 3 : UCIP_SP_2019_53424_23427.jpg

Comment Code						
Inspector Comment						
<p>FS_ID:53424 DS_ID:22622 EP_NO: 12208 Repair Type: Urgent Crossing Status: Found UCIP Comments: 10/18/2018 Same as previous inspection. No documentation is available to determine if there is a pipe integrity issue. Recommend internal inspection of the pipe through the levee to determine the condition of the pipe. Need to contact owner to obtain details of WS repair. Levee is about 8-10 feet high. Crossing remains Urgent due to the unknown reason for WS hole observed in the 2013 inspection (pipe repair or pipe leakage). (O. Magana - DWR UCIP)07/13/2016 Depression on WS berm has been backfilled, but the cause of the erosion was not addressed to my knowledge. As such, pipe integrity problem may still exist. Vegetation growth surrounds pipe on WS berm, in strike contrast to dry grass away from pipe alignment. This could be due to channel draining toward the pipe, or an indication of pipe leakage. (K. Fazel - UCIP)05/15/2013:- large pit at pipe daylight on WS berm, may be due to pipe leakage.- siphon breaker on LS shoulder not found. (P. Amatya - DWR) FIELD_STRUCT_DESC: 16-inch steel irrigation discharge pipe through the levee, 3 feet below the crown. 16-inch low-lift pump in the channel with a 1-inch electrical line also penetrating the levee to the power pole off the landside (LS) toe. 36-inch corrugated metal pipe (CMP) riser on the bank. Vent on the LS shoulder. Siphon breaker/vent on the apex of the pipe near the waterside (WS) pump. Standpipe off the LS toe. Pipe used seasonally only in the absence of groundwater, as per District President Joe Henderson. (16-inch irrigation pipe and 16-inch low-lift pump authorized under Permit No. 12208, 1977 - Thomas A. Cugueta). [Additional Reference(s): DWR Levee Log, 1993]. FS Date: 10/18/2018</p>

WS- pump and pipe on river bank

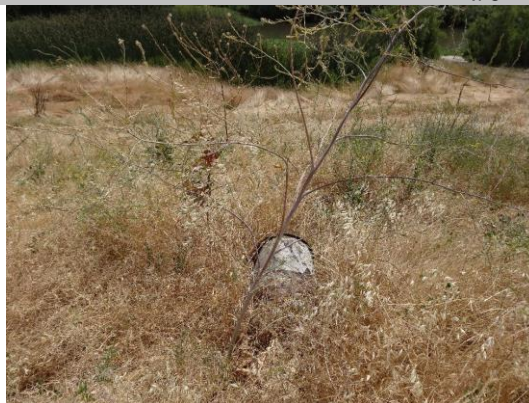
Photo 1 of 3 : UCIP_SP_2019_41674_23382.jpg

Comment Code					
Inspector Comment					
FS_ID:41674 DS_ID:22629 EP_NO: 2768 Repair Type: Non-Urgent Crossing Status: Found UCIP Comments: 01/24/2019 Attachment 1 under the 20141008 CVFPB acknowledgement letter indicates excavation and removal of pipe, backfill material, compact, and reseed. Need to confirm work and update UCIP record. (O. Magana - DWR UCIP) 05/15/2013 Pipe appears abandoned and if so should be done so properly.- Pipe capped on waterside.- a concrete pipe support saddle found on waterside levee slope.- also, an abandoned pipe found on landside levee slope. (P. Amatya - DWR UCIP) FIELD_STRUCT_DESC: 14-inch steel irrigation discharge pipe through the levee, 1.3 feet below the crown. Pump on the waterside (WS) toe removed. Gate valve on the WS slope removed. Pipe exposed on both slopes. Pipe discharges into a culvert on the landside (LS) toe which traverses under Pacific Avenue. (Removal and replacement of pump authorized under Permit No. 2768, 1958 - George N. Darrach). [Additional Reference(s): DWR Levee Log, 1993]. FS Date: 5/15/2013

WS- an abandoned pipe on levee slope

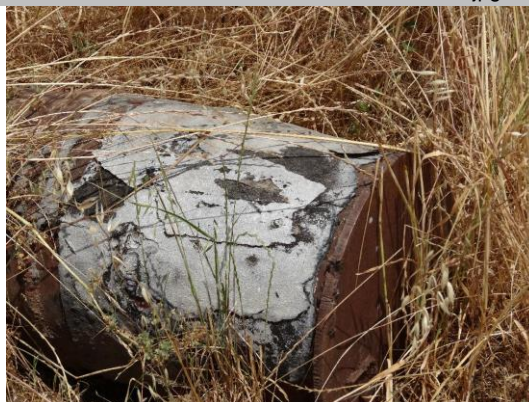
Photo 2 of 3 : UCIP_SP_2019_41674_23381.jpg

WS- an abandoned end capped pipe on levee slope

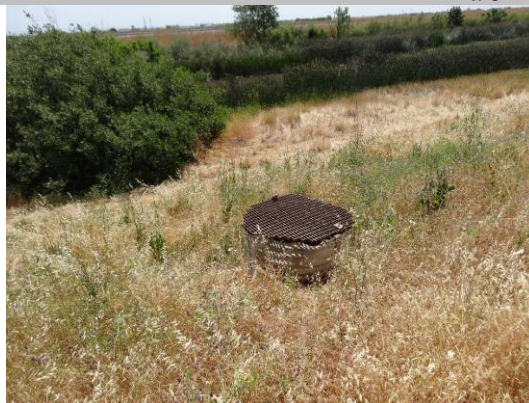
Photo 3 of 3 : UCIP_SP_2019_14167_23397.jpg

LM Start	3.28	Rating **	M	Issue No.	51 (cont)	
LM End	3.28	Issue Type +	En	Location *		
Category	Supplemental			GPS Latitude/Longitude		
				Start		End
Item	DWR UCIP Field Study			38.877706 °		38.877706 °
				-121.524787 °		-121.524787 °
DWR ID	22630					
Comment Code						
Inspector Comment						
FS_ID:14167 DS_ID:22630 EP_NO: N/A Repair Type: Non-Urgent Crossing Status: Found UCIP Comments: 05/15/2013 - pipe opens in irrigation ditch on landside.- vegetation cleaning on LS pipe opening. (P. Amatya - DWR UCIP) FIELD_STRUCT_DESC: 24-inch corrugated metal gravity drainage pipe through the levee, 12 feet below the crown. Slide gate in a 36-inch corrugated metal pipe (CMP) riser on the waterside (WS) slope. Concrete headwall at the landside (LS) toe. Pipe crosses under the channel. [Additional Reference(s): DWR Levee Log, 1993]. FS Date: 5/15/2013

WS- slide gate in CMP riser on levee slope

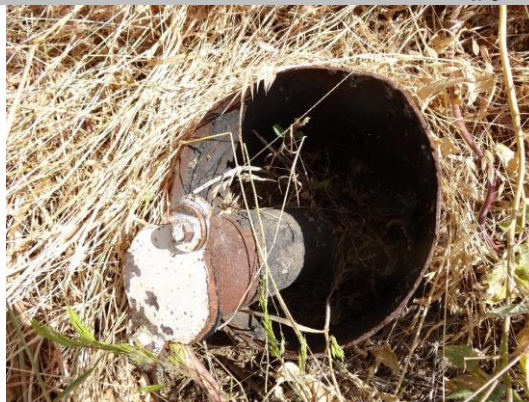
Photo 1 of 2 : UCIP_SP_2019_13523_22121.jpg

LM Start	3.43	Rating **	M	Issue No.	52
LM End	3.43	Issue Type +	En	Location *	
Category	Supplemental			GPS Latitude/Longitude	
				Start	End
Item	DWR UCIP Field Study			38.879960 °	38.879960 °
				-121.524780 °	-121.524780 °
DWR ID	22619				
Comment Code					
Inspector Comment					
FS_ID:13523					
DS_ID:22619					
EP_NO: N/A					
Repair Type: Non-Urgent					
Crossing Status: Found					
UCIP Comments: 05/15/2013 - needs filling/plugging gap between 4-inch and 10-inch pipes. (P. Amatya - DWR UCIP)					
FIELD_STRUCT_DESC: 1 of 2: Capped 4-inch steel irrigation pipe sleeved through a 10-inch steel pipe, at an unknown depth. Pipe exposed just off the top of the waterside (WS) slope. [Additional Reference(s): DWR Levee Log, 1993].					
FS Date: 5/15/2013

WS- a 4-inch steel pipe sleeved through 10-inch steel pipe.

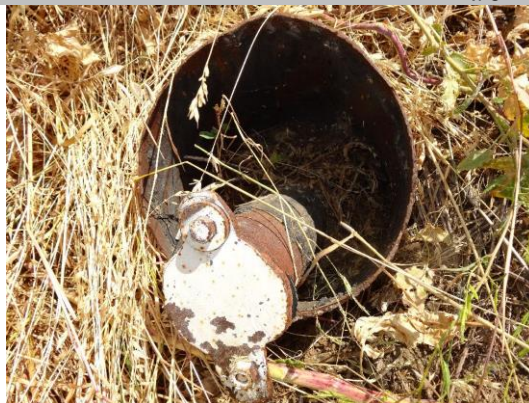
Photo 2 of 2 : UCIP_SP_2019_13523_22120.jpg

LM Start	3.43	Rating **	M	Issue No.	52 (cont)	
LM End	3.43	Issue Type +	En	Location *		
Category	Supplemental			GPS Latitude/Longitude		
				Start	End	
Item	DWR UCIP Field Study			38.879960 °	38.879960 °	
				-121.524780 °	-121.524780 °	
DWR ID	22619					
Comment Code						
Inspector Comment						
FS_ID:13523 DS_ID:22619 EP_NO: N/A Repair Type: Non-Urgent Crossing Status: Found UCIP Comments: 05/15/2013 - needs filling/plugging gap between 4-inch and 10-inch pipes. (P. Amatya - DWR UCIP) FIELD_STRUCT_DESC: 1 of 2: Capped 4-inch steel irrigation pipe sleeved through a 10-inch steel pipe, at an unknown depth. Pipe exposed just off the top of the waterside (WS) slope. [Additional Reference(s): DWR Levee Log, 1993]. FS Date: 5/15/2013

WS- gap between two pipes needs to be filled.

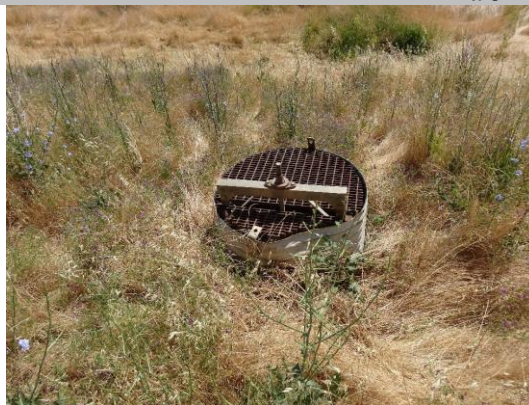
Photo 1 of 2 : UCIP_SP_2019_13509_22086.jpg

LM Start	3.59	Rating **	M	Issue No.	53
LM End	3.59	Issue Type +	En	Location *	
Category	Supplemental			GPS Latitude/Longitude	
				Start	End
Item	DWR UCIP Field Study			38.882247 °	38.882247 °
				-121.524762 °	-121.524762 °
DWR ID	22631				
Comment Code					
Inspector Comment					
FS_ID:13509 DS_ID:22631 EP_NO: N/A Repair Type: Non-Urgent Crossing Status: Found UCIP Comments: 05/15/2013 Only a small section of head wall visible, almost buried. (P. Amatya - DWR UCIP) FIELD_STRUCT_DESC: 24-inch corrugated metal gravity drainage pipe through the levee, 12 feet below the crown. Slide gate in a 36-inch corrugated metal pipe (CMP) riser on the waterside (WS) slope. Concrete headwall at the landside (LS) toe. Pipe crosses under the channel. [Additional Reference(s): DWR Levee Log, 1993]. FS Date: 5/15/2013

WS- fixed slide gate in CMP riser on levee slope.

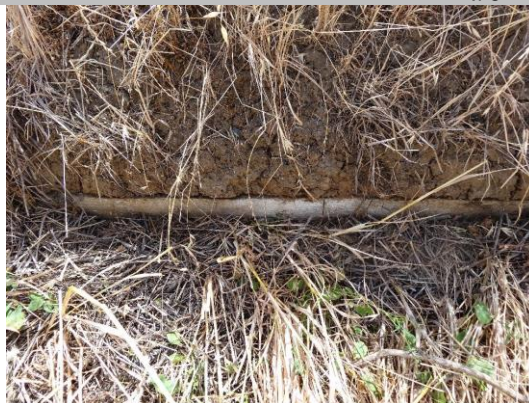
Photo 2 of 2 : UCIP_SP_2019_13509_22085.jpg

LM Start	3.59	Rating **	M	Issue No.	53 (cont)	
LM End	3.59	Issue Type +	En	Location *		
Category	Supplemental			GPS Latitude/Longitude		
				Start	End	
Item	DWR UCIP Field Study			38.882247 °	38.882247 °	
				-121.524762 °	-121.524762 °	
DWR ID	22631					
Comment Code						
Inspector Comment						
FS_ID:13509 DS_ID:22631 EP_NO: N/A Repair Type: Non-Urgent Crossing Status: Found UCIP Comments: 05/15/2013 Only a small section of head wall visible, almost buried. (P. Amatya - DWR UCIP) FIELD_STRUCT_DESC: 24-inch corrugated metal gravity drainage pipe through the levee, 12 feet below the crown. Slide gate in a 36-inch corrugated metal pipe (CMP) riser on the waterside (WS) slope. Concrete headwall at the landside (LS) toe. Pipe crosses under the channel. [Additional Reference(s): DWR Levee Log, 1993]. FS Date: 5/15/2013

LS- almost burried concrete headwall. Only upper portion of the wall is visible.
